Technician Bulletin—Troubleshooting for CK1543

Undercounter Dishwashers

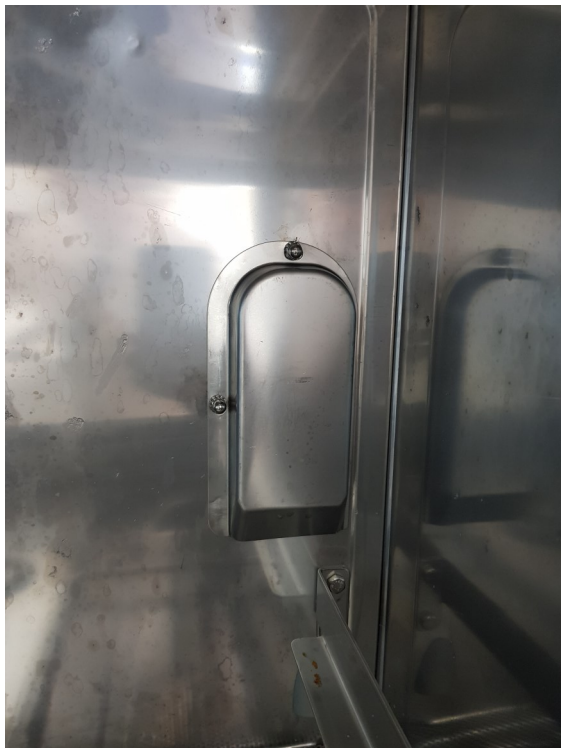
Pic 1

A common problem, that our customers report, is due to poor maintenance of the air trap.

The air trap is located on the back wall inside the washing chamber (Pic 1). A build up of dirt behind the metal protection means the machine may either over or under fill.
